## FIELD EVALUATION OF ENGINEERING GEOLOGIC HAZARDS OF AN EMBANKMENT DAM CONSTRUCTED ACROSS A MAJOR, ACTIVE PLATE BOUNDARY, FAULT

**Azm S. Al-Homoud**

### ABSTRACT

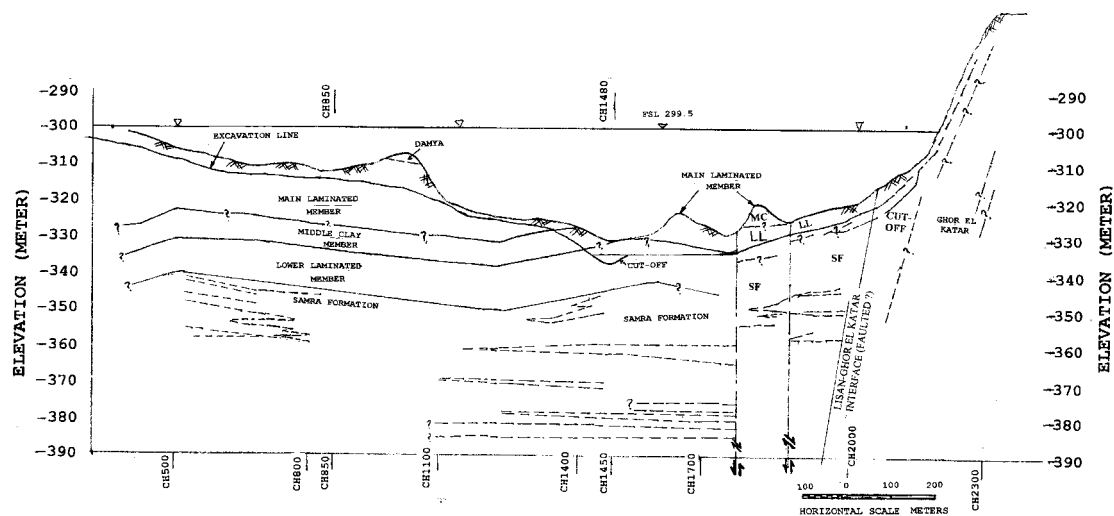
Fig. 3 Geologic Cross Section Along Dam Axis

However only the Samra Formation/deposits and Lisan Formation/deposits are exposed at the site (Fig. 3).

These contain a range of structures including convoluted bedding, jointing and sinkholes.

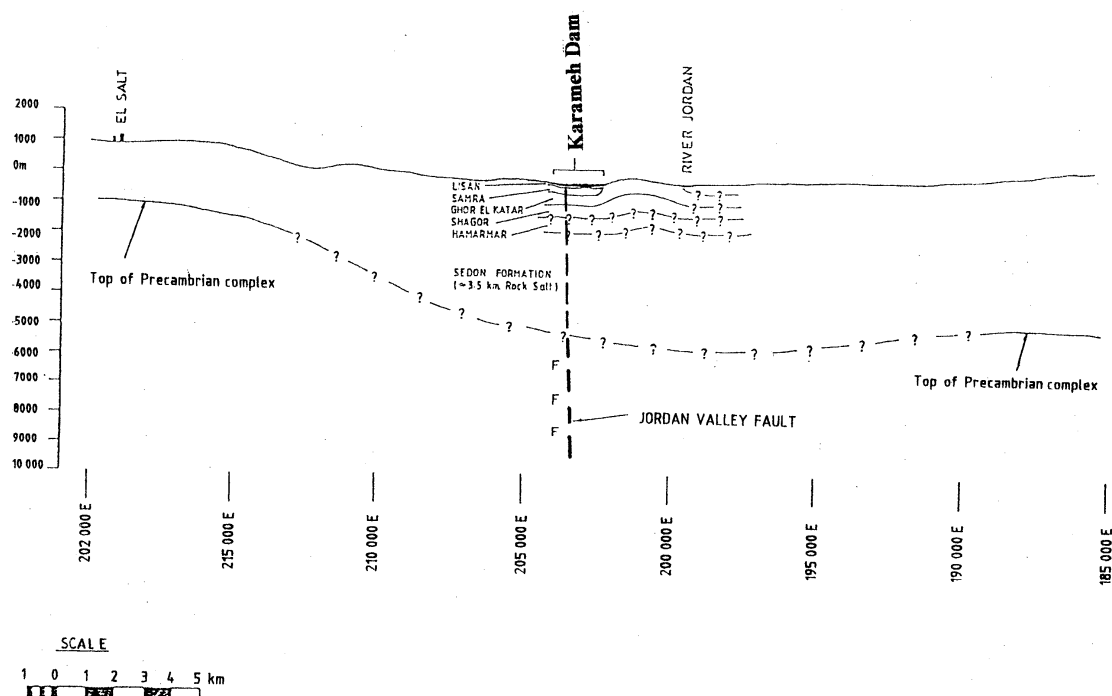
**Fig. 5** Geologic Cross Section of the Jordan Valley Looking South Showing the Location of the Karameh Dam and the Geologic Formations Under the Dam (Modified After Sir Alexander Gibb and Partners, 1992a).

(Fig. 4). This fault zone extends beneath the site of the dam and reservoir in the eastern side of the right embankment (Fig. 5). Rather than a single linear fault, this is a major movement zone consisting of a principal fault and numerous secondary faults and fractures. The presence of the extensive faulting at the site is implied by numerous steep-sided gullies possibly formed by the incised drainage.

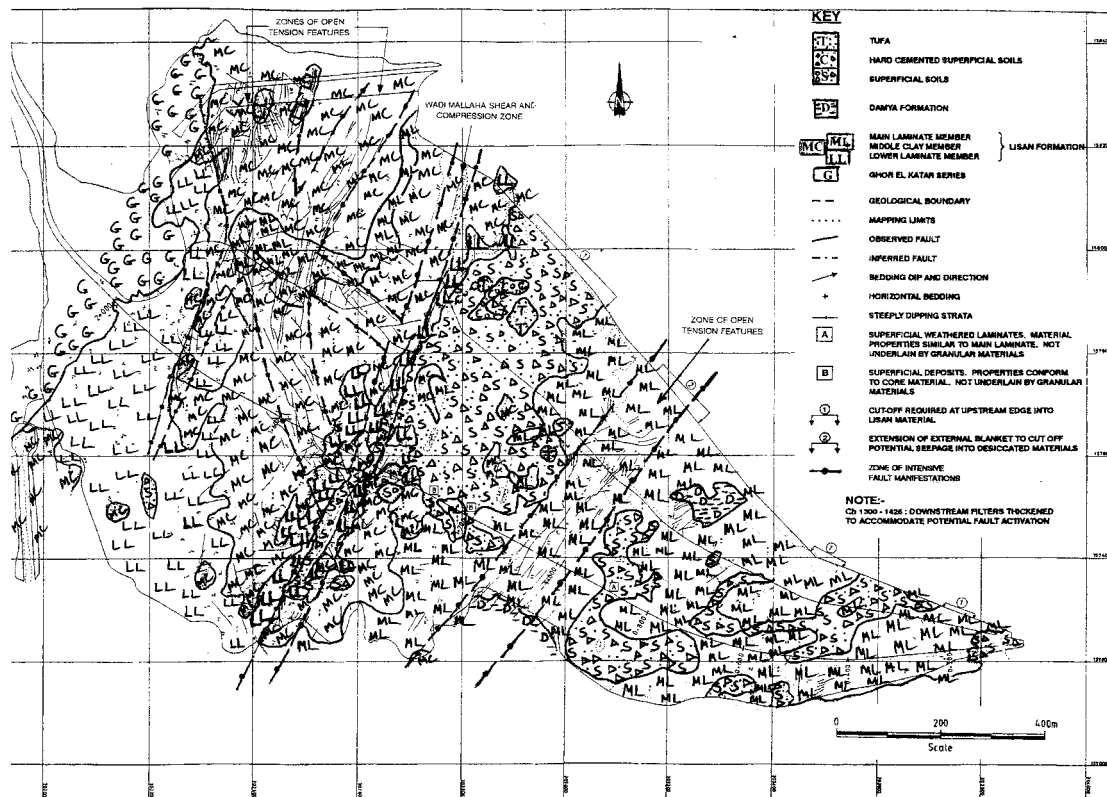
Fig. 6 As Excavated Geology (Sir Alexander Gibb and Partners, 1997).

As the foundation of the dam was exposed during the dam construction, a detailed geological interpretation of the site was prepared. Fig. 6 gives the geological mapping of the surface outcrop at formation level of the dam footprint including the external blanket area. This simplified geological map is a reduction of a 1:2,000 map. A longitudinal geological section along the dam axis at 1:1,000 was also produced as shown in Fig. 3.

Fig. 6 shows:

- 1) A geological stratigraphy that closely matches that identified during the site investigations
- 2) Three main structural features:
  - a) A zone of open sub-vertical tension features striking NE/SW, crossing the dam centre line at approximately Ch 1100.

- b) A zone of principal movement along the original line of the Wadi Mallaha - (the Wadi Mallaha Shear Zone) trending NNE/SSW
  - c) A shear zone of open sub-vertical features, similar to that at Ch 1100, which strikes N from the dam centre line at approximately Ch 1500 before swinging NE SW as it crosses the approach channel. This zone has a number of subsidiary off-shoots as shown on the map. The zones of open sub-vertical tension features are typically graben type structures, characteristic of extensional tectonics, exhibiting overall total vertical movements of the order of 2 - 4 m but with no indication of any lateral movement. These features were identified during the site investigations at Karameh, prior to construction and the dam was designed to withstand the earth movements likely to create such phenomena.

The Wadi Mallaha Shear Zone represents the zone of principal tectonic movement across the site in that it exhibits compressional deformation probably involving box type folding and an echelon shear of the strata. Although the Wadi Mallaha Shear Zone has an apparent downthrow of less than 5 m towards the west, compression within the zone has resulted in local movements of up to 6 m. It has not been possible to assess the extent of any lateral movement along the zone due to the horizontal nature of the strata at Karameh. As this is the zone of principal deformation, the dam filters have been thickened across it (Ch 1300 and Ch 1425).

Three Zones where significant faulting has occurred have now been identified. These are shown on Fig. 6:

The downstream filter was thickened by 2 m and the drain by 2 m from Ch. 1300 to 1425 to make the dam more earthquake resistant in the event of reactivation of this fault.
