## SETTLEMENTS OF AN EMBANKMENT FOUNDED ON A SOFT SOIL

### **Abstract**

The construction of a pre-loading embankment was begun in December 2001. The total height of the embankment, which remained in place until March 2002, was 9 m, and it was founded on a marshland soft soil. Because of the nature of the foundation soil, a monitoring system was installed in order to assess the embankment settlements. The measurements of settlements were obtained by field instrumentation, which consisted of ten settlement plates, enabling optical levelling measurements at these points, and one measuring tube, which was installed beneath the embankment and used to assess the settlement profile of the embankment using a hydrostatic profile gauge. The settlements measured by the hydrostatic profile gauge showed a continuous increase in the vertical displacement after the end of construction for approximately half a year. The maximum measured settlement was 43 cm. It was shown that the results are very similar to those observed on settlement plate SP-3, which was located very close to the measuring tube. The use of a measuring tube and a hydrostatic profile gauge, which do not interfere with the const

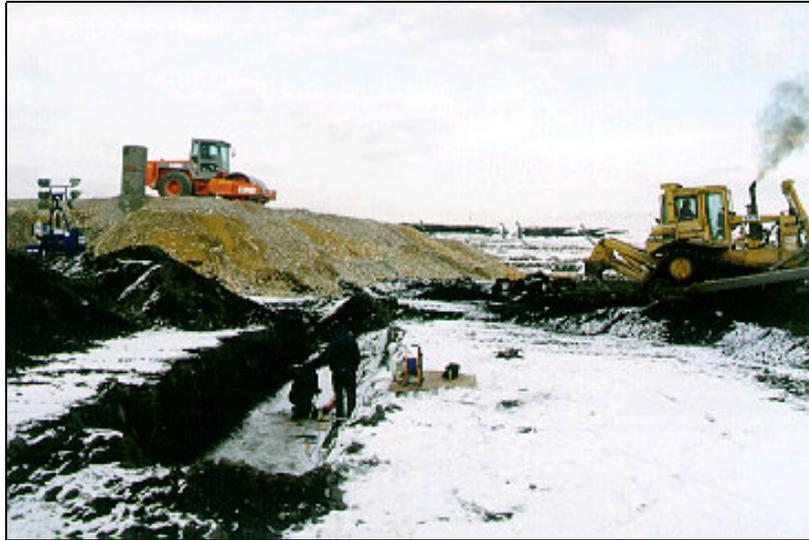
Figure 2. The embankment at an early stage of construction

Construction of the pre-loading embankment, which was founded on a compressible marshland soft soil, was begun in December 2001 (see Figure 2). It remained in place until March 2002 (see Figure 3). The lower strata of the embankment were 3 m high and made from ash from a thermo-electric power plant, whereas the upper strata, made from the crushed stone, were 6 m high. The total height of the embankment was thus 9 m.

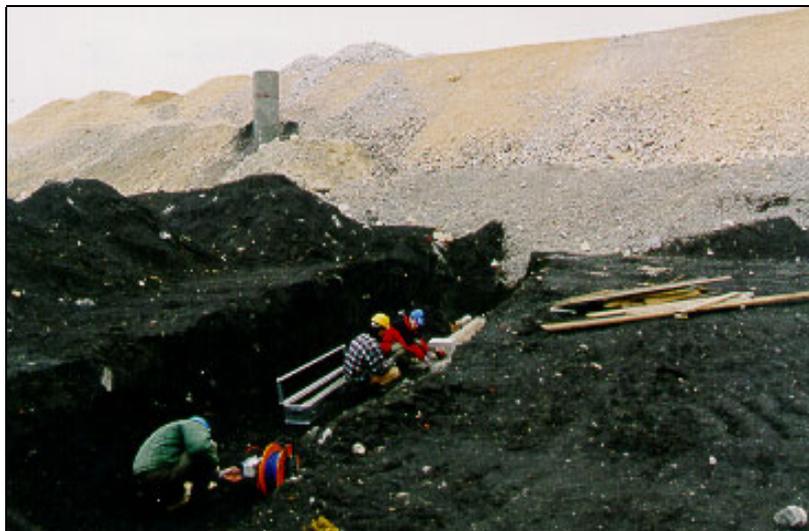
Figure 3. The completed embankment

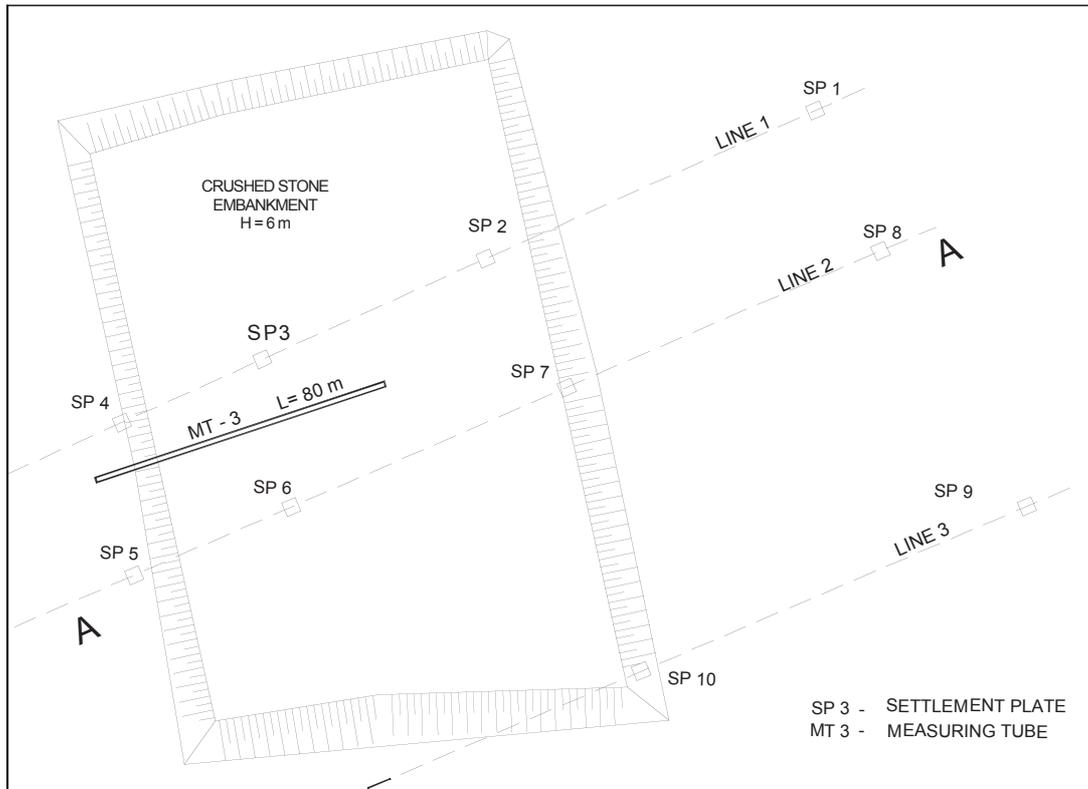
Figure 4. Field instrumentation of the embankment – plan

Settlements were measured by means of field instrumentation, which consisted of 10 steel settlement plates (SP-1 to SP-10), laid in 3 lines across the embankment, and 1 plastic measuring tube (MT-3, length = 80 m), placed at the selected profile (see Figure 4). The settlement plates were installed at the bottom of the lower stratum of the embankment, just ahead of the start of the construction works. The measuring tube was placed in an ash stratum,

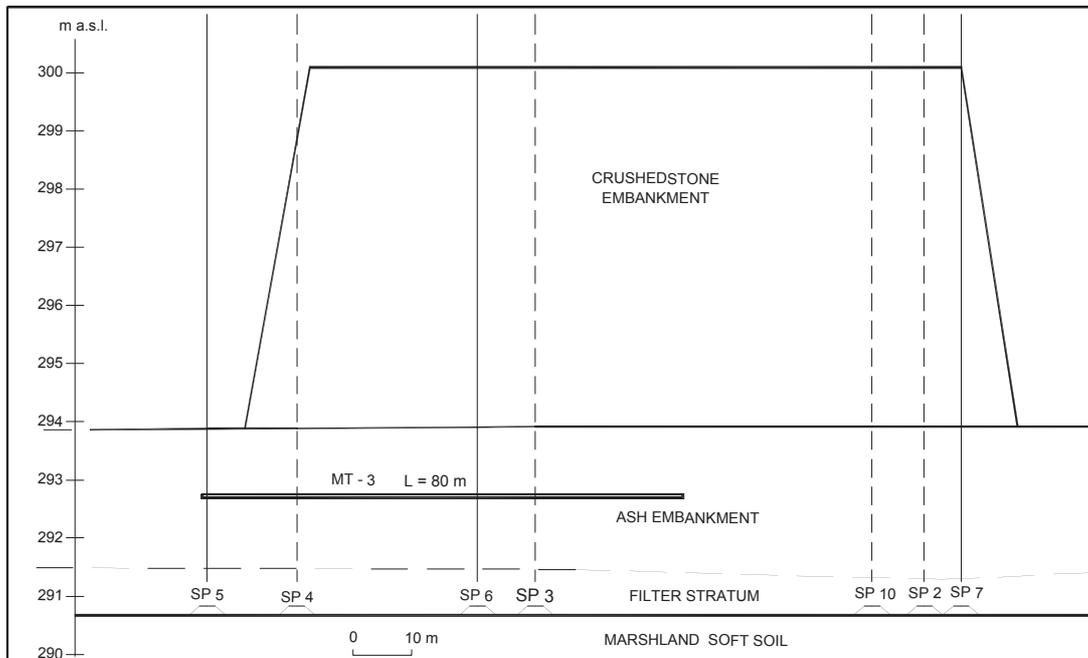
Figure 5. Field instrumentation of the embankment – cross section A-A

about 1.0 m below the crushed stone embankment, after the ash embankment had been completed (see Figure 5). Movement of the plates was determined by conventional geometric levelling, whereas the vertical movement of the tube, at points 0.5 m apart, was monitored using a hydrostatic profile gauge.

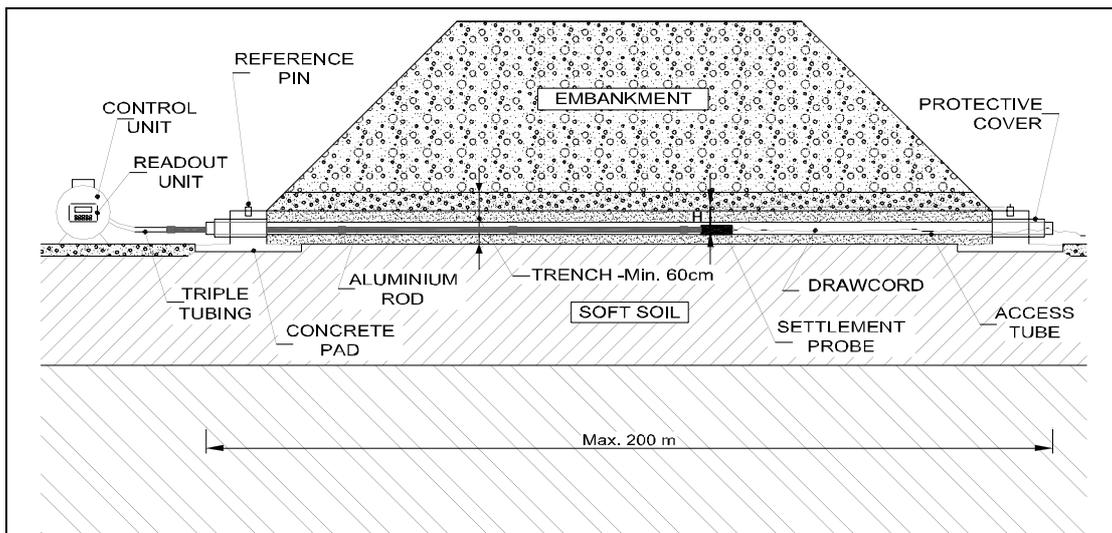
Figure 6. Schematic arrangement of the hydrostatic profile gauge

The hydrostatic profile gauge consisted of a control unit, a readout unit and a length of triple tubing connected to a settlement probe, which can be pushed (with aluminium rods) or pulled (with a draw-cord) through the access tube (see Figures 6 and 7). Two of three small tubes are filled with water and are constantly back-pressurized in order to overcome surface tension effects, and to prevent the formation of bubbles. Measurements of elevation are taken at regular intervals in an access tube, which is laid in a sand-filled trench. The hydrostatic head at the probe 'H' is measured with the aid of a differential pressure transducer. These readings are related to a reference pin outside the tube and in this manner a complete profile of the tube can be established. By comparing profiles taken at different times, the vertical displacement of the tube can be determined to an accuracy of  $\pm 1.0$  cm, which is excellent for this application.

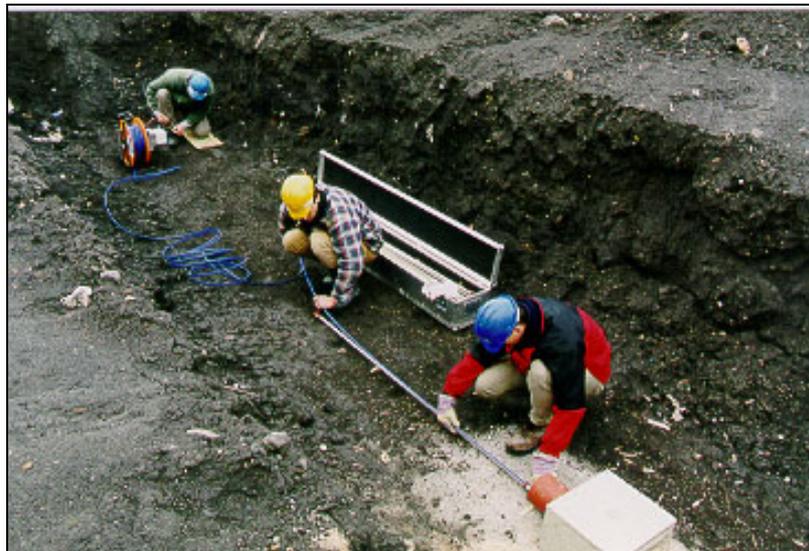
Figure 7. Measurement using the hydrostatic profile gauge (the probe is being pushed)

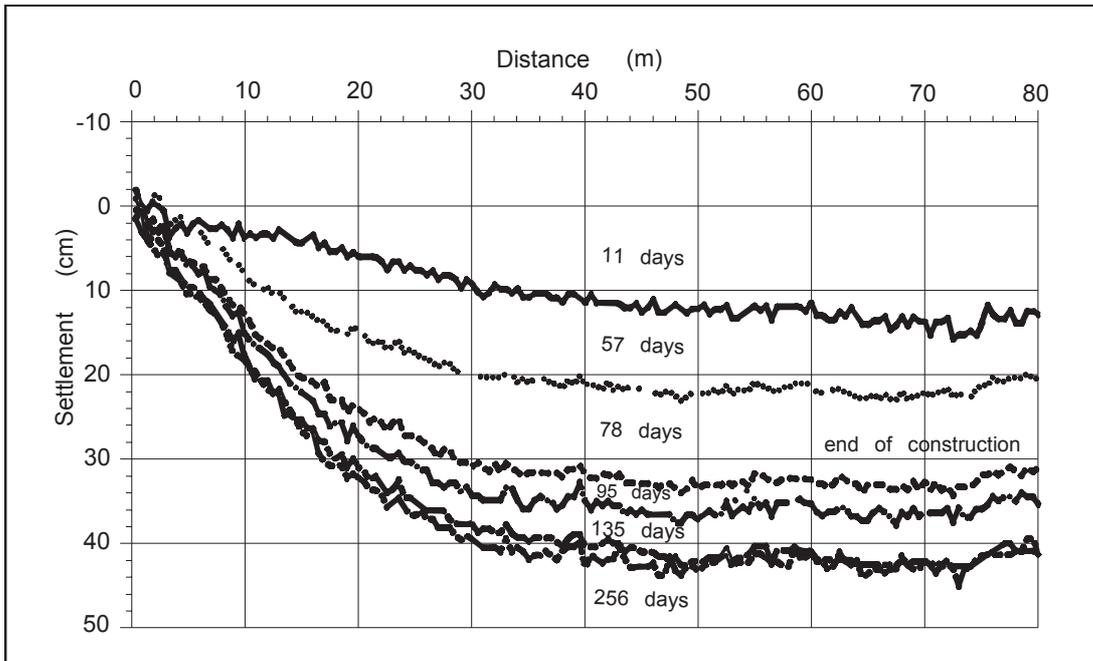
Figure 8. Settlement profiles at different times (since the 1st measurement) along the measuring tube MT-3

Figure 8 shows the settlements measured using the hydrostatic profile gauge along the measuring tube MT-3, at points 0.5 m apart, at different times since the 1st measurement. The settlements showed a continuous increase in vertical displacement after the end of construction for approximately half a year. It can be seen that, 256 days after the 1st measurement, the maximum measured settlement was 43 cm.

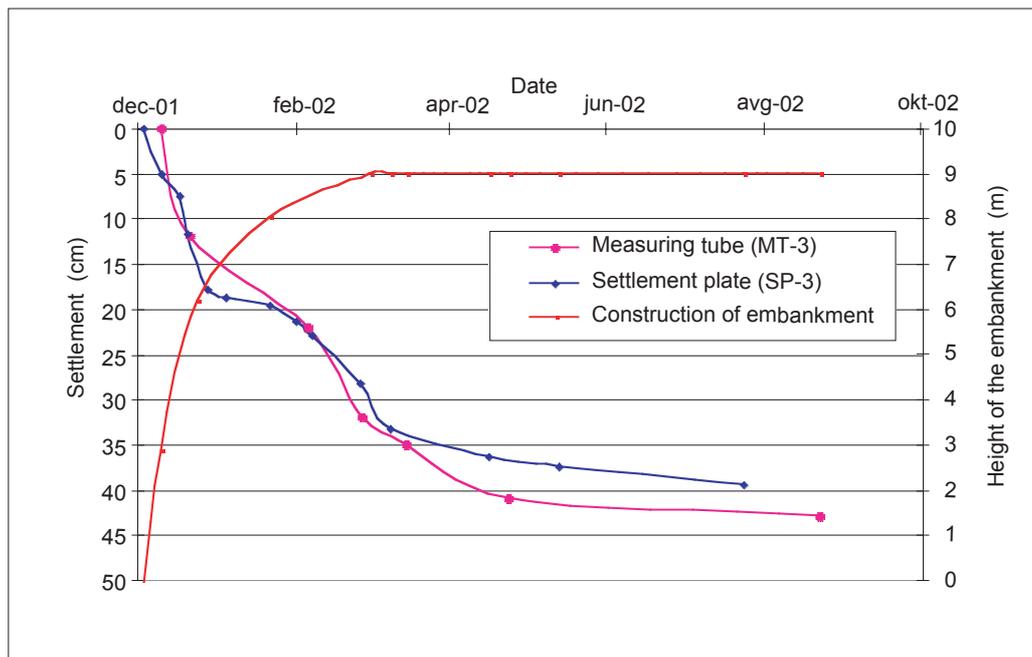
Figure 9. Settlement development measured using 2 different methods, compared to the progress of embankment construction

Figure 9 shows a comparison of settlement development measured in the measuring tube MT-3 with the settlements observed on plate SP-3, which was located very close to the tube (see Figure 4), and progress of the embankment construction. The measurements were not all carried out at the same time, and the measuring tube was installed about 2 m above the mentioned settlement plate (see Figure 5), which had problems connected with the attachment of riser pipes and also with movements due to the effect of site transport. In spite of all this a comparison of the two different methods shows that the magnitude of the measured settlements and the settlement development are very similar.
