The Impact of the 2010 Darfield and 2011 Christchurch Earthquakes on the Geodetic Infrastructure in New Zealand

FIG Working Week 2011, Marrakech, Morocco

Graeme Blick
Land Information New Zealand

John Beavan
GNS Science

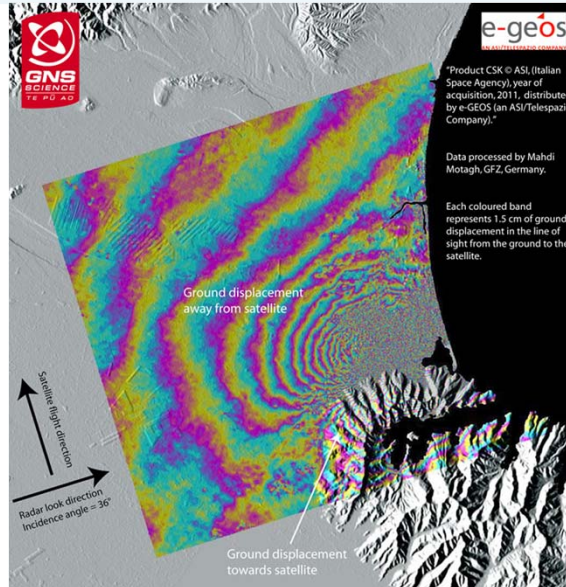
InSAR interference pattern as a result of the Christchurch earthquake.

Each coloured fringe represents 1.5 cm of ground displacement in line-of-sight to the satellite

Incoherent regions indicate ground damage

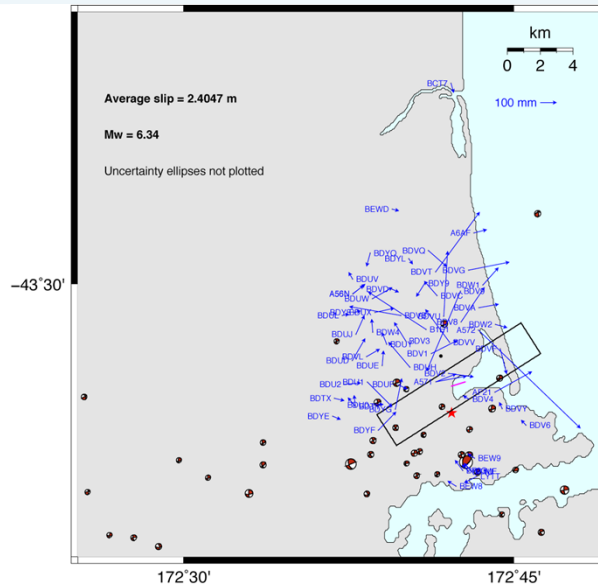
Large residuals (> 60 mm horizontal)

Evidence of lateral spreading or other ground failure

- Models will enable possibly 90% of geodetic and cadastral marks to be updated from the Darfield earthquake
- Models will enable maybe less than 50% of geodetic and cadastral marks to be updated from the Christchurch earthquake
- This will result in the need to resurvey much of the geodetic in the Christchurch area
- It will also result in the need to resurvey much of the cadastre – this may not happen in the short term
