Automated Remote monitoring for Earthquake Recovery Work FIG Working Week May 2016

# The Issue: Monitoring of a hillside hazard The Solution: Automated remote monitoring The issues considered:

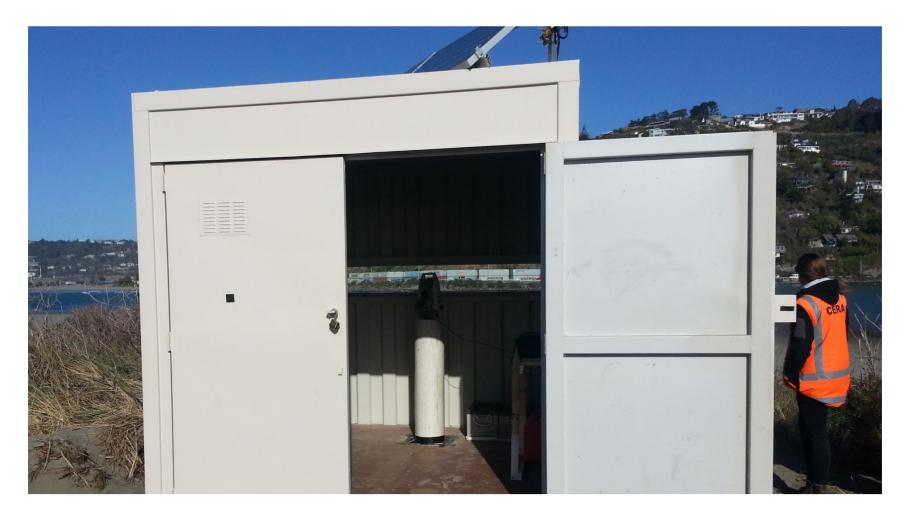
# Site Setup

## **Outside the container**

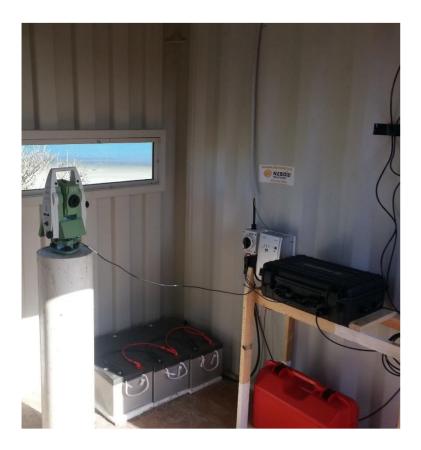
Inside the container

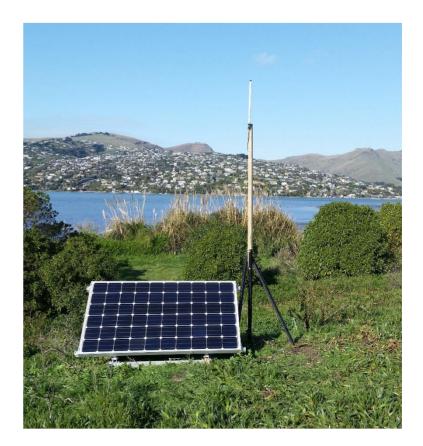
**Radio repeater**

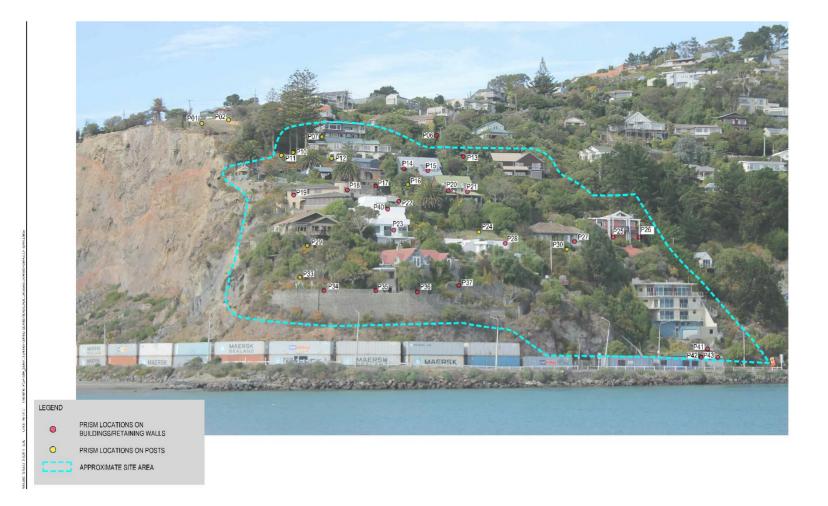
# Monitoring site showing prism locations
