## FIELD EVALUATION OF ENGINEERING GEOLOGIC HAZARDS OF AN EMBANKMENT DAM CONSTRUCTED ACROSS A MAJOR, ACTIVE PLATE BOUNDARY, FAULT

**Azm S. Al-Homoud**

### ABSTRACT

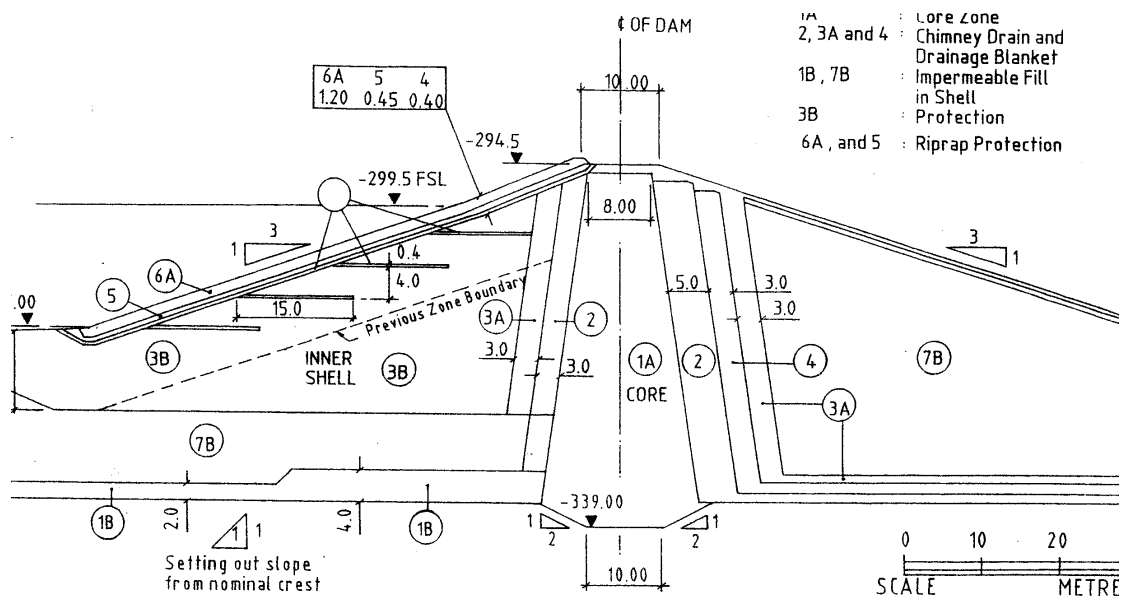
Fig. 2 gives the main zones of a typical cross-section of Karameh dam.

**Fig. 2** Main Zones of a Typical Cross-Section of Karameh Dam.

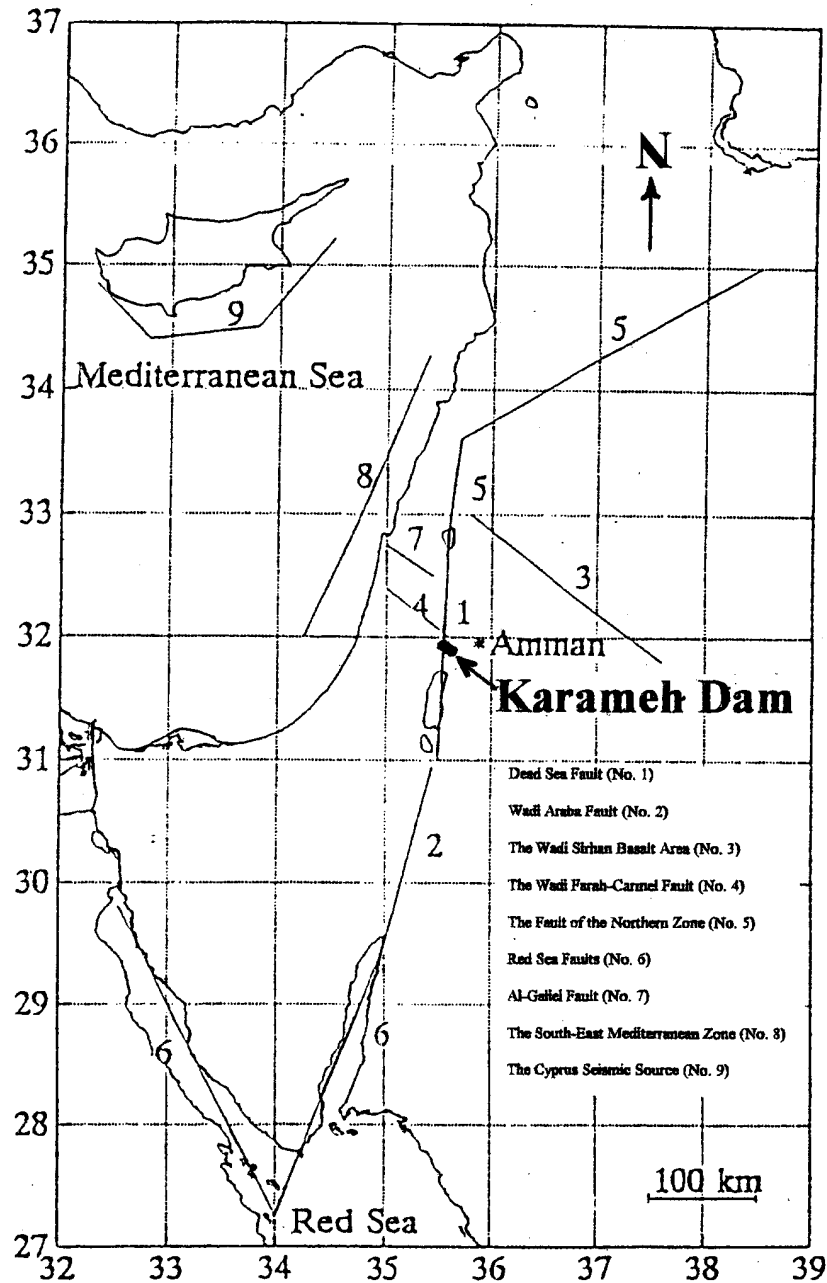
Based upon the field mapping, a major fault referred to as the main Jordan Valley Fault, trends approximately north-south and runs at least 75 km from the Dead Sea to Lake Tiberias

(Fig. 4). This fault zone extends beneath the site of the dam and reservoir in the eastern side of the right embankment (Fig. 5). Rather than a single linear fault, this is a major movement zone consisting of a principal fault and numerous secondary faults and fractures. The presence of the extensive faulting at the site is implied by numerous steep-sided gullies possibly formed by the incised drainage.

**Fig. 4** Tectonic Map of Jordan Showing Location of Major Faults Including Jorda Valley Fault and Dead Sea - Jordan Transform Fault System.

The right abutment of the dam is highly fractured while the foundations contain cavities, gypsum and halite. Moreover, geological sections show the existence of continuous layers of loose liquefiable sand (Al-Homoud et al, 1995). The most prominent structural feature in Jordan is the Dead Sea-Jordan Rift System. This transform fault system, more than 1000 km long, links the Zagros-Taurus zone of plate convergence to the north with the Red sea to the south where crustal spreading occurs. The Dead Sea Rift (Jordan Valley Rift) was formed during the Cenozoic break up of the once continuous Arabo-African continent. The plate boundary movement in Jordan was strike-slip with a total left-lateral movement of some 105 km (Sunna, 1994). Some individual faults have a length of over 40 km (Fig. 4).
