Chief Assist. Prof. Dr.-Eng. Gintcho Kostov **University of Forestry, Bulgaria**

2. 3D terrestrial laser scanning of the buildings. Technical difficulties

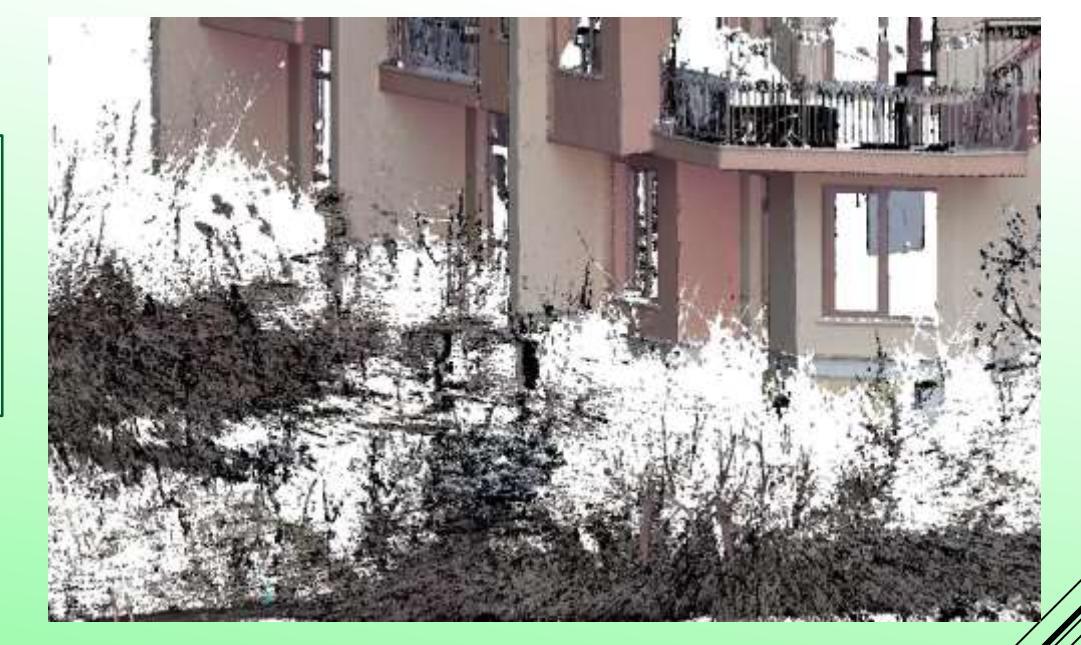
Fig. 1 The point cloud and the bushes around the buildings

The bushes, having **various heights and density**, were one significant technical difficulty to be solved.

In the process of laser scanning, the presence of **(tall) bushes** all around the buildings had

to be taken into account, fig. N 1.

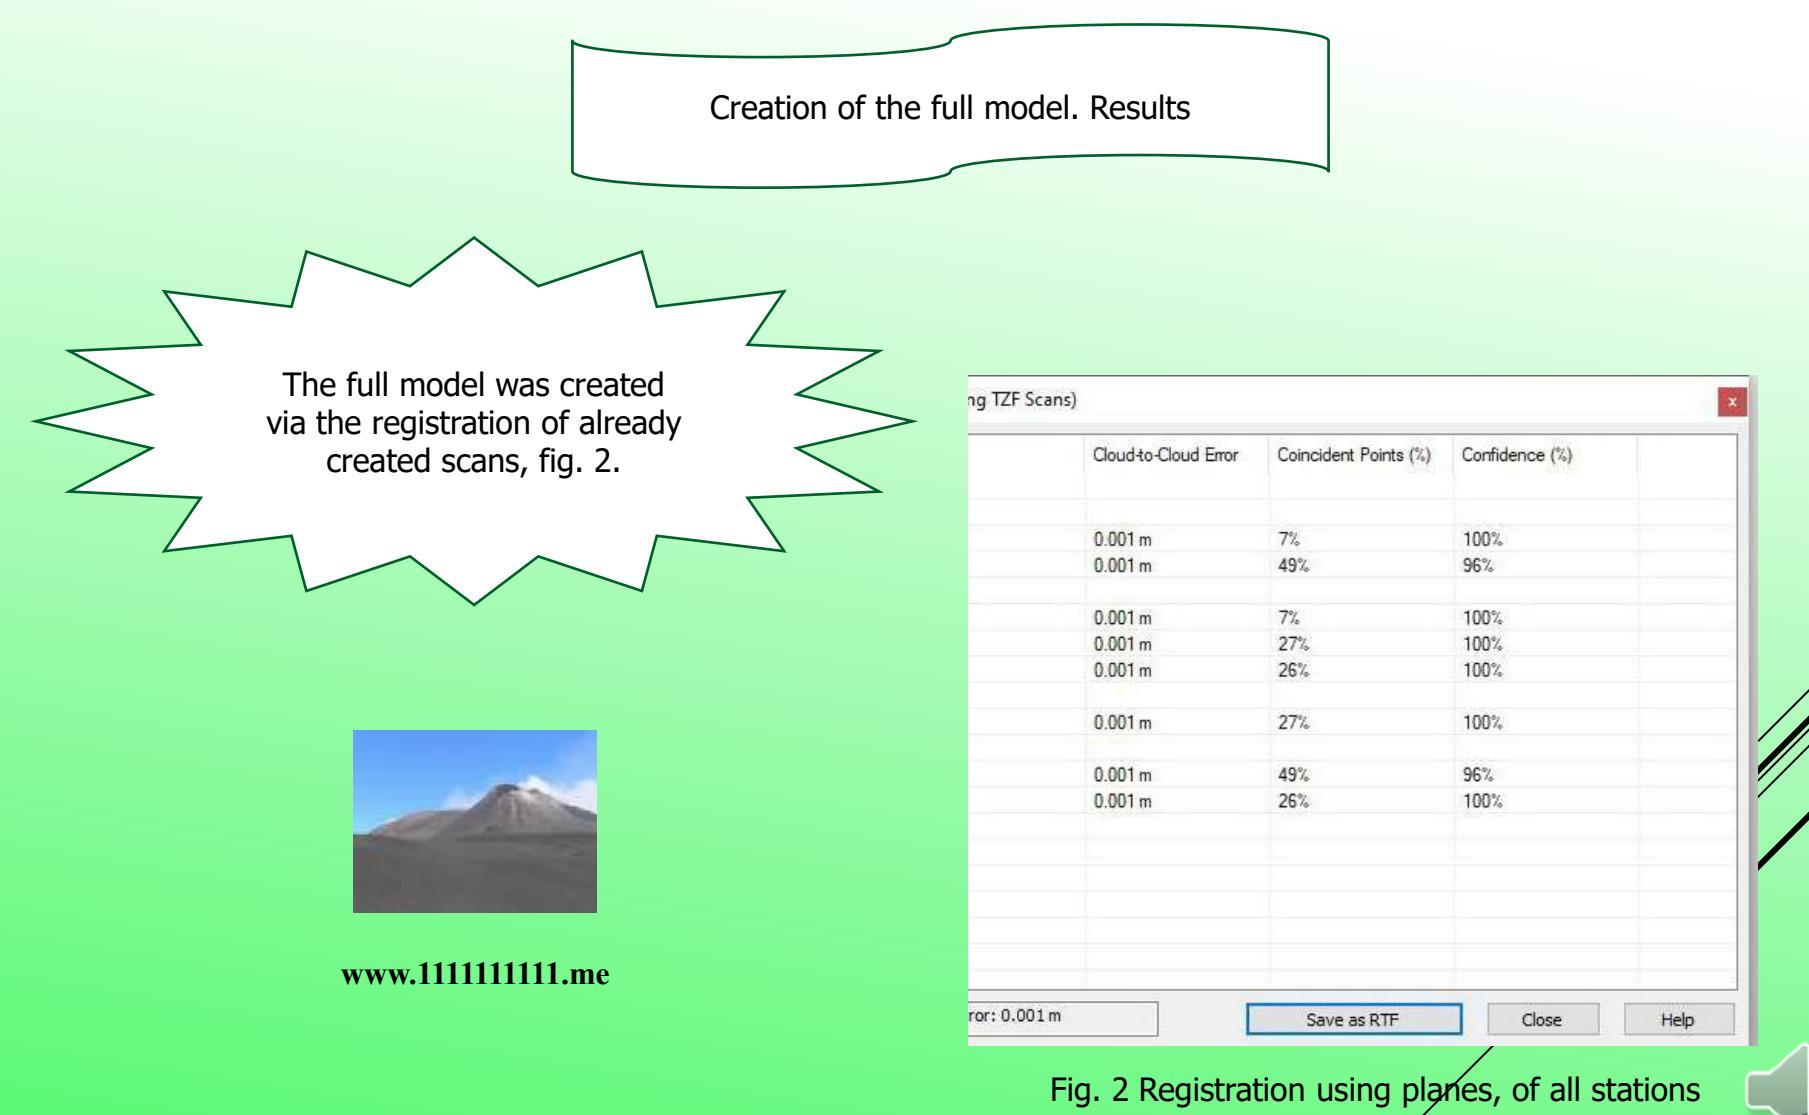
5. Results from 3D terrestrial laser scanning. Analysis

- a) **1 mm** in the registration process;
- b) **9 mm** in the georeferencing of the point cloud.

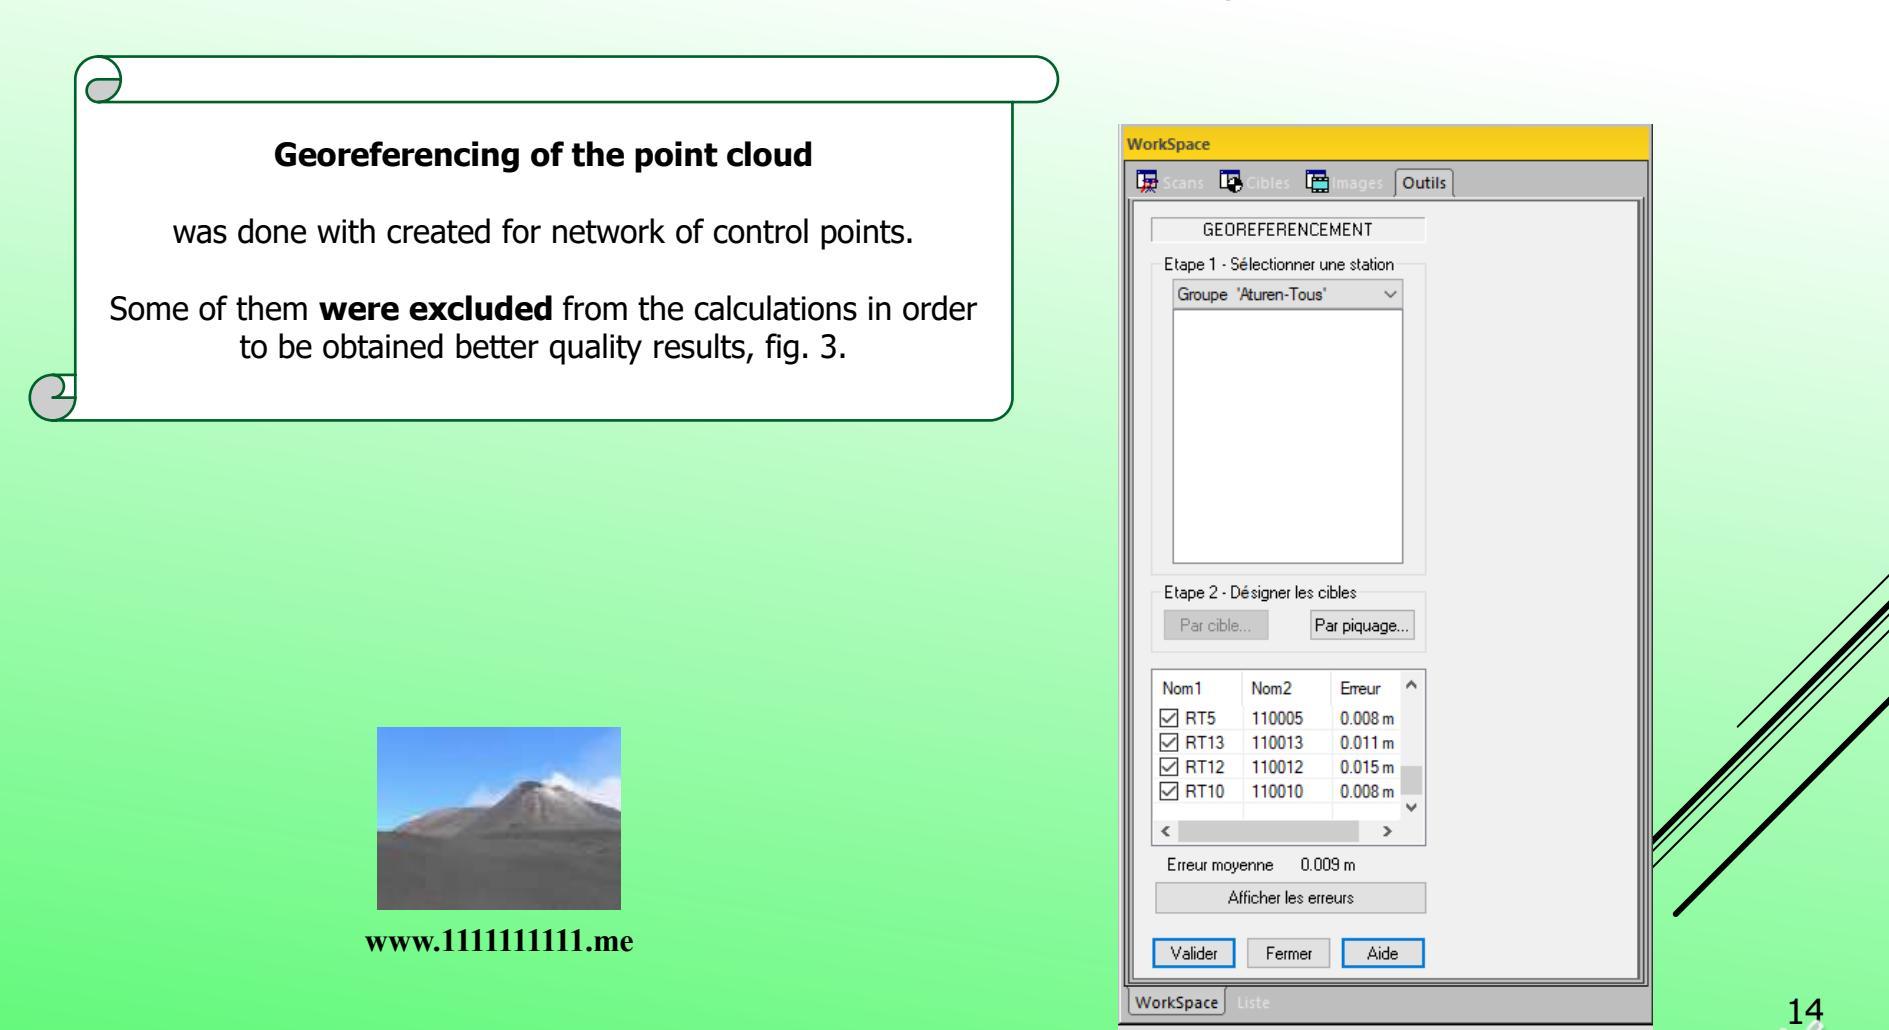
6. Results from 3D terrestrial laser scanning. Analysis
