Assessing the Quality of an UAV-based Orthomosaic and Surface Model of a Breakwater

Maria João HENRIQUES, Ana FONSECA, Dora ROQUE, José Nuno LIMA, João MARNOTO, Portugal

Key words: UAV, mapping, coordinates, quality control, monitoring, breakwater

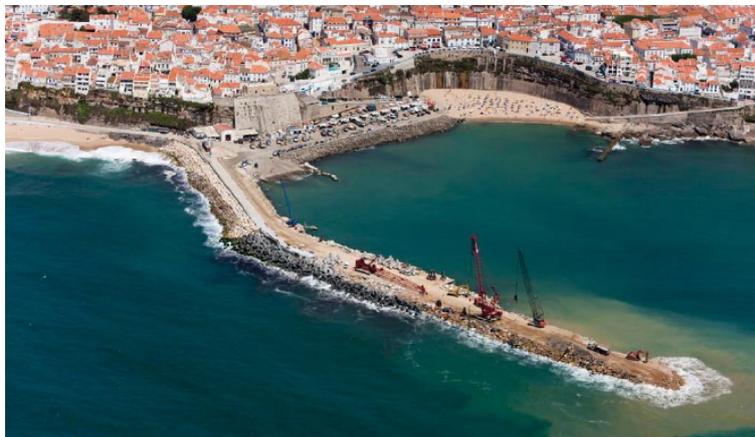
Figure 1 – Reconstruction of the breakwater of the port of Ericeira.

The port of Ericeira is mostly used by the local fisherman community. The advanced deterioration of the original protection of the quay (built on the 1970's) was a consequence of the effect of the highly energetic north-westerly Atlantic Ocean waves on a underdimensioned breakwater. A comprehensive study made by the National Laboratory for Civil Engineering (LNEC) in the 2000's focused on the analysis of the status of pier under the perspective of its reconstruction and development of the port. The first stage of rehabilitation is already completed (Figures 1 and 2) and focused on rebuilding the breakwater and constructing new areas and buildings to support fishing activity.

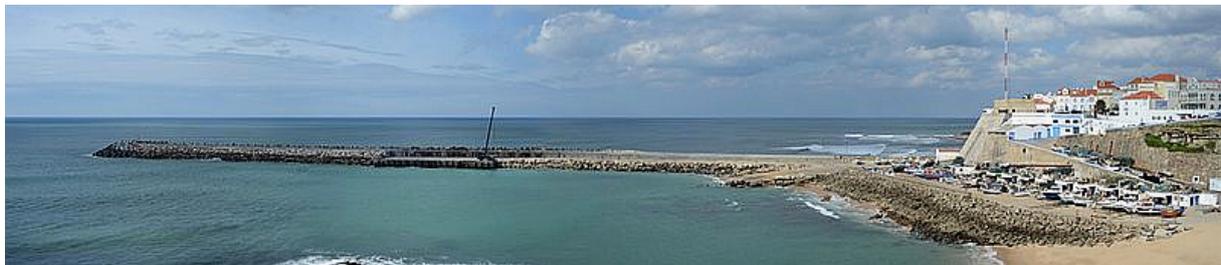
Figure 2 – Breakwater of the port of Ericeira after the rehabilitation.

The new rubble mound breakwater (RMB), longer and much stronger, has created a wider area of waters sufficiently calm to allow safe operations of berthing, cargo transfer, vessels manoeuvre and the protection of port infrastructures. The breakwater is 440 m long and 35 m wide. It consists of two straight lengths, angled of 147° to each other. The crest is 6.5 m wide and has an altitude of 9 m (referred to the hydrographic zero). The main elements of this breakwater are a core of finer material covered by big blocks (armor layer). Beneath the armor layer it was placed a filter layer, called underlayer, to prevent the finer material of being washed out through the armor layer.

Along the entire crest and on half of the leeside are two superstructures in concrete, being that the lowest one includes a quay. The most exposed slope of the breakwater (facing the northwesterly waves) is covered with tetrapods; the southwest extremity, which has on the top a small lighthouse, is covered with grooved cubes; the remaining areas are covered with large stones.

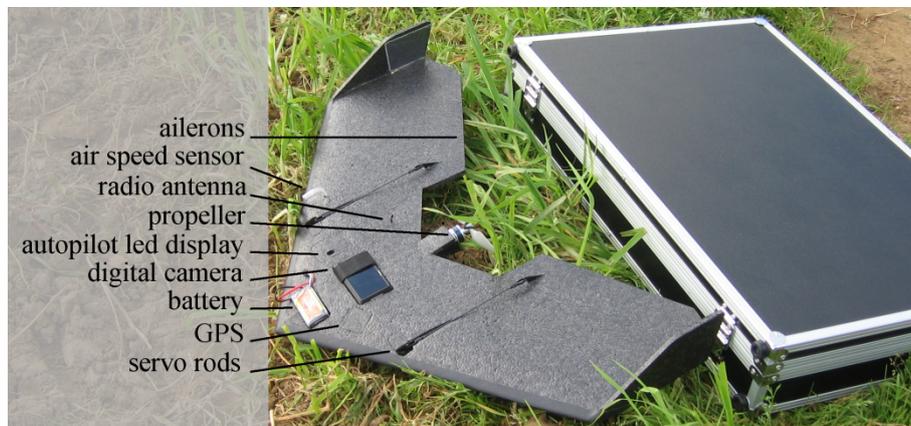
Figure 3 - Swinglet CAM and carrying case

The photos were taken by a digital camera Canon IXUS 220 HS (3000×4000 pixels), mounted on the platform SenseFly Swinglet CAM (Figure 3), a very light (500 g) and small (80 cm wingspan) plane. The emission of data like battery level, speed of the wind, position of the UAV, a transmission that was made every 0.25 s to a control unit on land, would allow the monitoring of the flight.. The control unit consists of the software eMotion (from Sensefly), installed on a laptop, this one with an external radio antenna for communication. A more comprehensive description of the system can be found in Vallet et al.(2011).

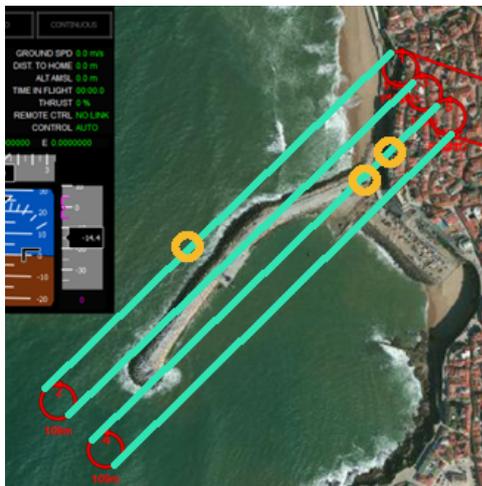
Figure 4 – Flight path over Ericeira breakwater.

During the flight there were problems with the transmission of data so the ground station received very few records from the airplane. When this was over the breakwater the ground station only received about 2% of the data expected, data that would have allowed to estimate the location of the airplane (latitude, longitude, altitude), its attitude, speed, etc.

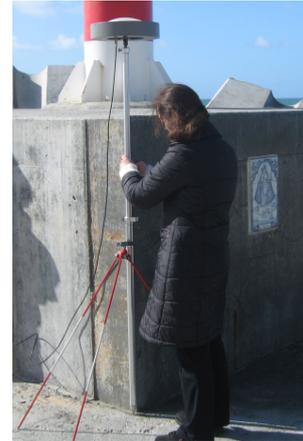
Figure 10 – Coordinating a point near the lighthouse.

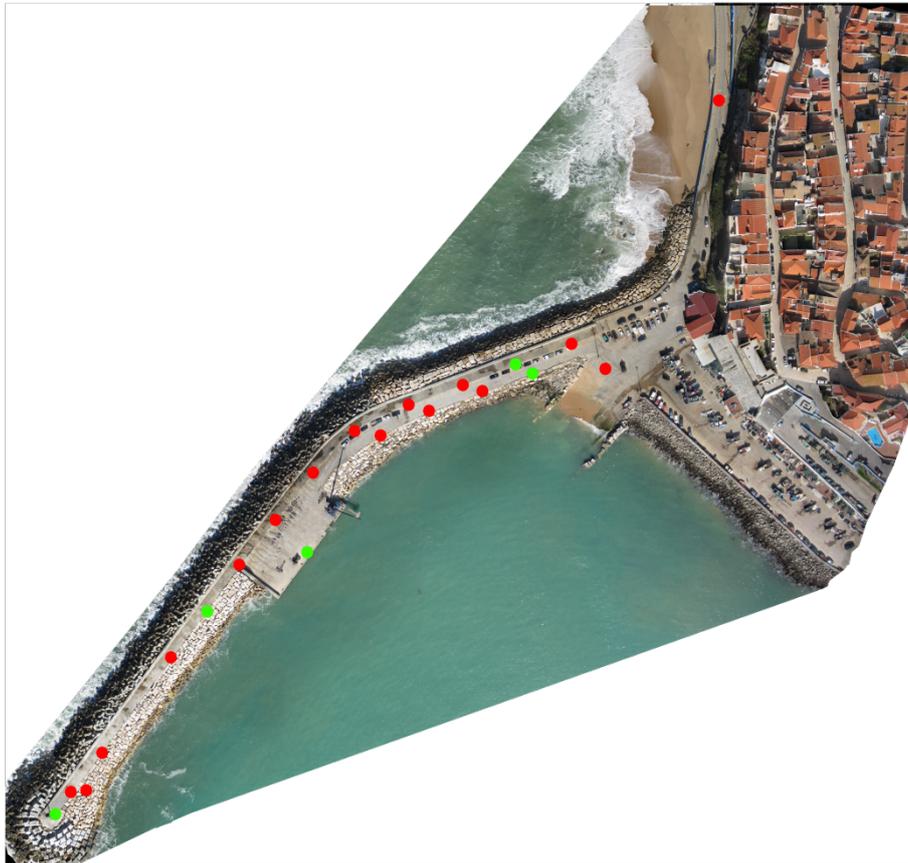
Figure 11 – Orthomosaic. Location of the ground control points.

We determined the coordinates of several points (ground control points) of the superstructure of breakwater (Figure 11) by GNSS to reference the orthomosaic and the surface model and to assess planimetric and altimetric positional quality. We chose points that could be easily identified on the images (Figure 8), like the corners of the several square manhole covers placed along the superstructure (Figure 9) or the corners of the concrete base of the lighthouse (Figure 10). The points were coordinated using two Topcon choke ring antennae: one was placed on a tripod on the breakwater (reference station) and remained there during the surveying; the other was placed on the top of a stick and was placed on each point for three minutes. GNSS data was recorded at a period of 1 second. We calculated geodetic coordinates, in the ETRS89 reference frame, and cartographic coordinates, in the national coordinate system PT-TM06, using the software Pinnacle and GNSS data of the nearest station of the Portuguese CORS Network.

The orthomosaic (Figure 11) is an orthogonal projection of the ground from which it is possible to get, only, planimetric coordinates. It is the result of the combination of two photogrammetric processing tools: the ortho-rectification (correcting imagery for distortion induced by elevation using elevation data and camera model information) and the mosaicking (process of taking two or more separate images and "stitching" them together into a single image). To have information about height is necessary to build the digital surface model, which was derived from a point cloud generated also by the same software. The surface is described by a set of discrete points, independent of each other. Each one has only three attributes: the three coordinates. In Figure 12 we present the point cloud (perspective of the breakwater) where we assigned a color to each point based on its altitude. In this phase we generated, from the point cloud, a mesh composed of triangles for visualization purposes (Figure 13).
